12.0 Mexican Hat, Utah, Disposal Site

12.1 Compliance Summary

The Mexican Hat, Utah, Disposal Site, inspected on April 24, 2007, was in good condition. Runoff from storm events continues to transport sediment into the west diversion channel resulting in low-density vegetation growth within the entire length of the channel; however, the performance of the diversion channel has not been impaired. Tamarisk plants found on site were cut and treated with herbicide. Trash and tumbleweeds continue to accumulate on the site and along sections of the perimeter fence. A seismic monitoring station was installed inside the perimeter fence at the site as part of the EarthScope USArray Project; data will be collected for two to three years.

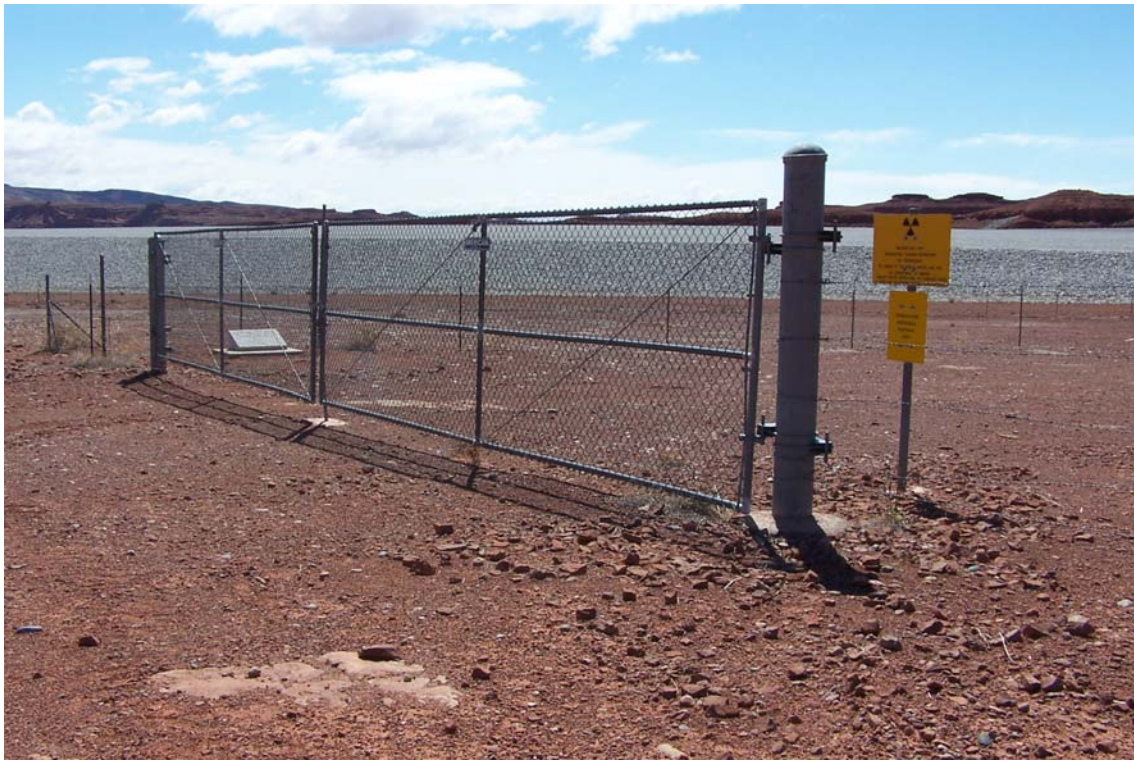
A barbed-wire perimeter fence set inside the property boundary, with a chain-link gate at the site entrance, encloses the site. The center rod to the entrance gate is damaged, causing the west half to be inoperable; however, vehicles can still access the site through the east half of the gate and, therefore, no repairs are planned at this time (PL–1).

An entrance sign is located at the gate and was in excellent condition (PL–1). There are 43 perimeter sign locations along the property boundary and each location has a pair of signs: an upper property ownership sign and a lower radioactive materials disposal site warning sign. Some perimeter signs have bullet holes or were dented but were legible. Perimeter sign P37 is missing the lower radioactive materials disposal site warning sign. The remaining signs were in excellent condition.

HAT 4/2007. PL-1. View of the site entrance gate, entrance sign, and site marker SMK-1; the disposal cell in the background.

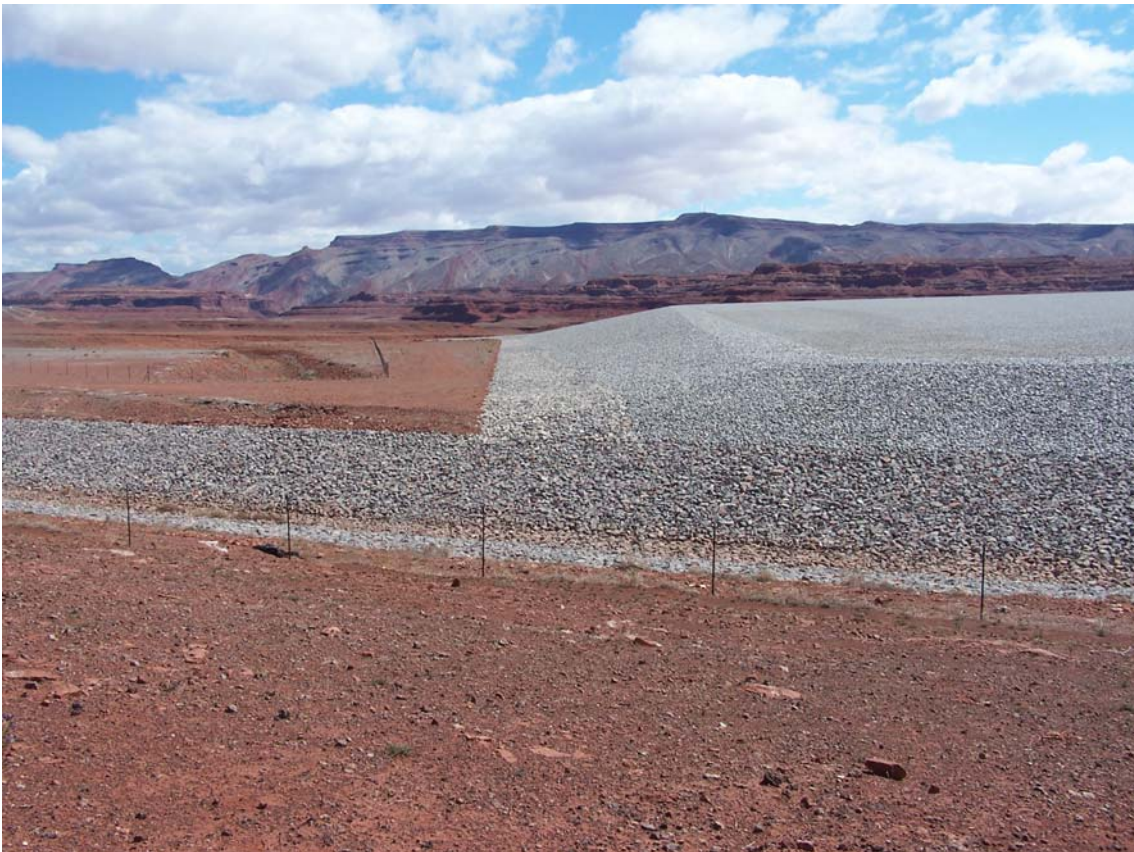
Top of Disposal Cell—The top of the riprap-armored disposal cell was in excellent condition (PL-2). There was no evidence of differential settling, cracking, burrowing, or other modifying processes that could affect the integrity of the cell. All visible components of the disposal cell and cover were functioning as designed. No vegetation was observed to be growing on top of the disposal cell.

HAT4/2007. PL-2. The northwest corner and side slope of the disposal cell.

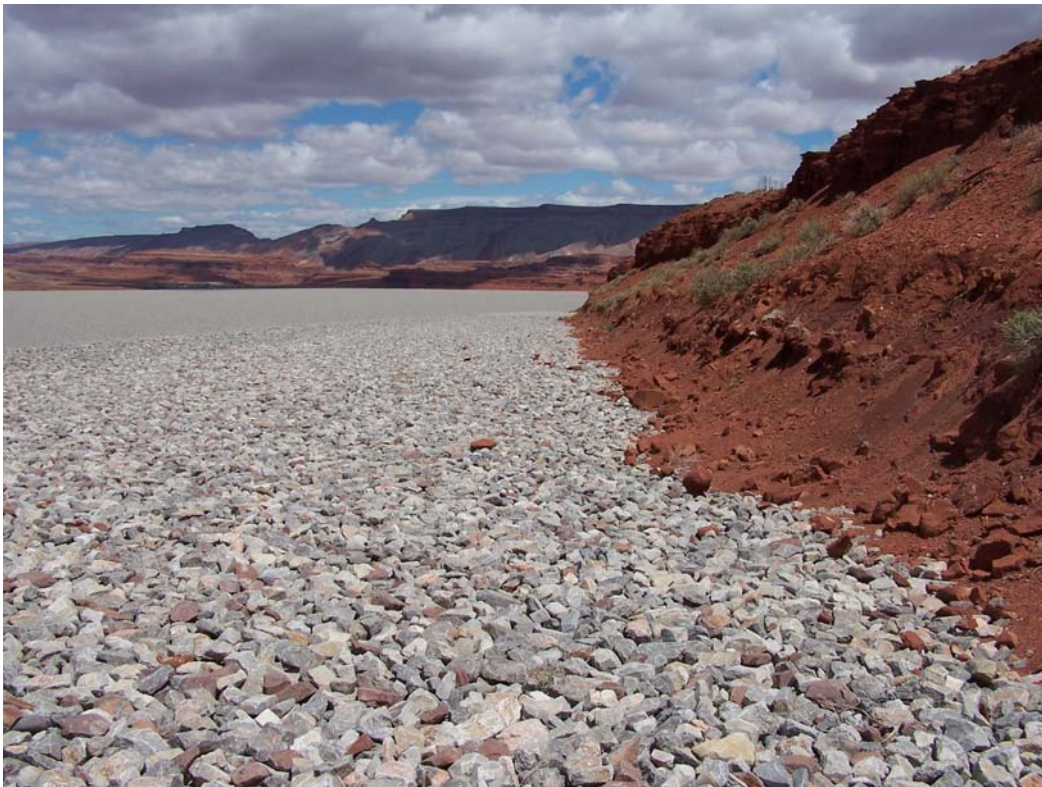
A section along the south apron has been monitored since construction because rock and soil have sloughed off the adjacent steep hill slope onto the apron. Based on comparisons with photographs from previous inspections, there was no significant increase in accumulation of the red sandstone and soil along the south apron (PL-3). As observed in past years, there was no evidence of channel erosion in this area, and the sloughed material has not filled the void spaces in the apron riprap beyond the toe of the hill slope. It is anticipated that a minor amount of unstable rock from the hill slope will, over time, continue to fall onto the apron; however, the amount of material that will eventually accumulate on the edge of the apron in this area will have no detrimental impact on the performance of the apron or the disposal cell. Nevertheless, inspectors will continue to observe material that has fallen and accumulated on the edge of the apron in this area as a BMP.

HAT 4/2007. PL-3. The disposal cell apron along an area that tends to slough; no change from previous year.

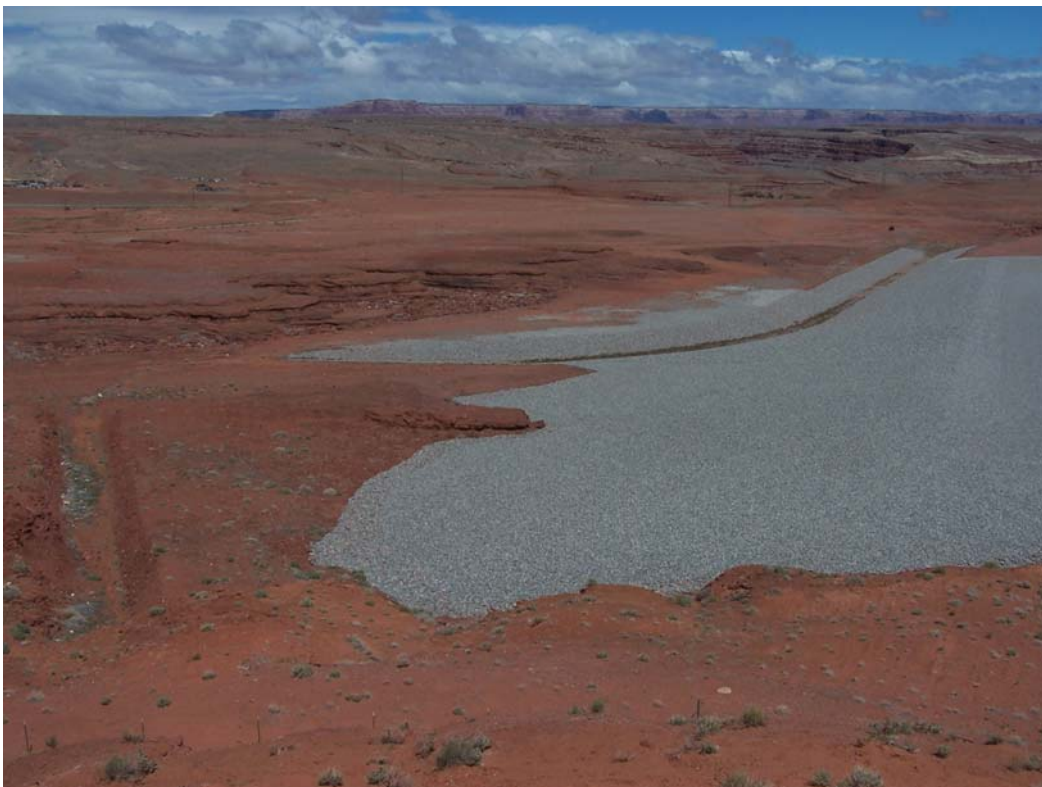
Areas off-site and upslope continue to erode and transport sediment into the west diversion channel and the southwest ditch. Plant growth, primarily annual weeds, is establishing where the sediment has accumulated in the west diversion channel (PL-4). The sediment accumulation and plant growth have not affected the performance of these storm water diversion structures, and the rate of sedimentation is expected to diminish as the upgradient landscape stabilizes.

HAT 4/2007. PL-4. View of the west portion of the disposal cell, showing sediment and vegetation in the west diversion channel.

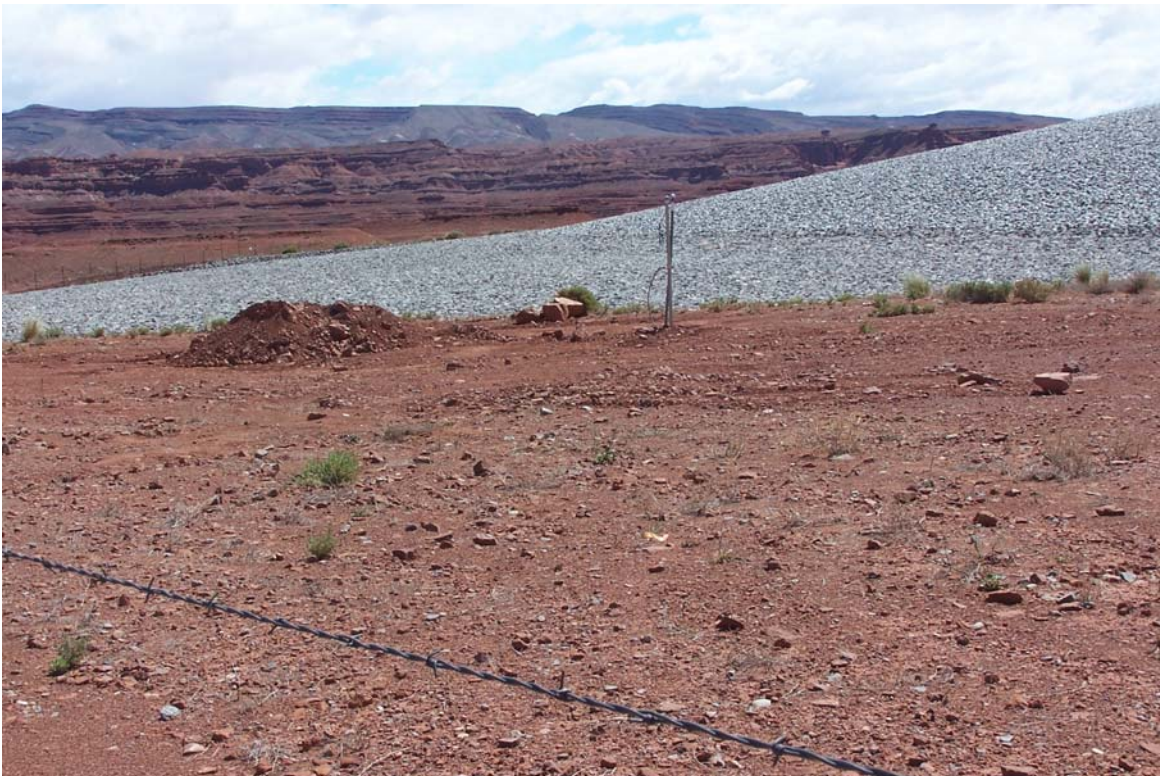
- 12D A seismic monitoring station was installed inside the perimeter fence on the north side of the disposal site (PL-5). This seismic monitoring is being conducted under the EarthScope USArray Project; a project funded by the National Academy of Sciences for the purpose of collecting seismic data every 200 square miles across the entire continental United States and Alaska. The seismic monitoring station will collect data at the site for a period of two to three years, at which time the station will be removed. The disposal site was desirable, in part, because it is located in a controlled area. This monitoring supports DOE's effort to provide site reuse, as desired, under the Legacy Management Program.

HAT 4/2007. PL-5. USArray seismic monitoring station at the base of the disposal cell's north side slope and west of the north toe drain.

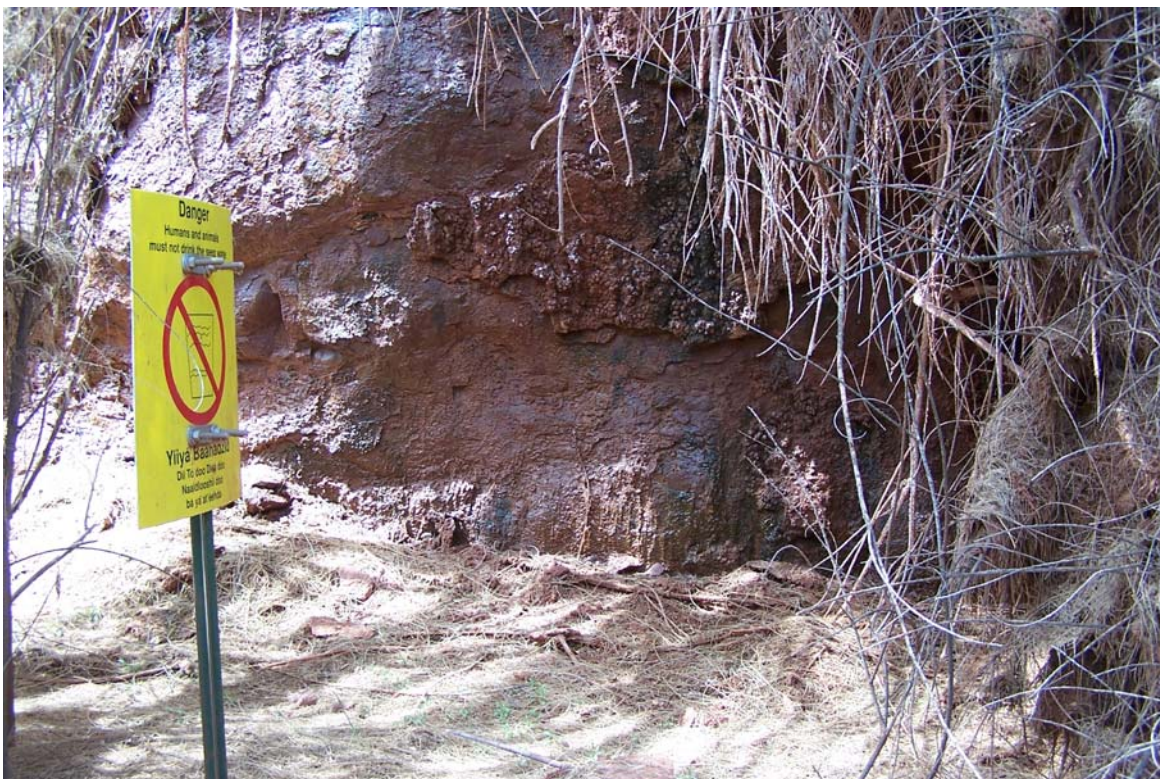
In 2007, the most significant flow was observed in seep 0248, located in Gypsum Creek and downgradient from the disposal cell (PL-6). The flow was similar to that found in 2006, with only a very small amount of standing water in a pool approximately 1 foot in diameter and 1 inch in depth. Seep flow was observed to be running down and dripping from the rock face above the small pool. No flow occurs past the small wetted area. Besides tamarisk, only a minimal amount of riparian vegetation is found at this location.

HAT 4/2007. PL-6. Seep 0248.

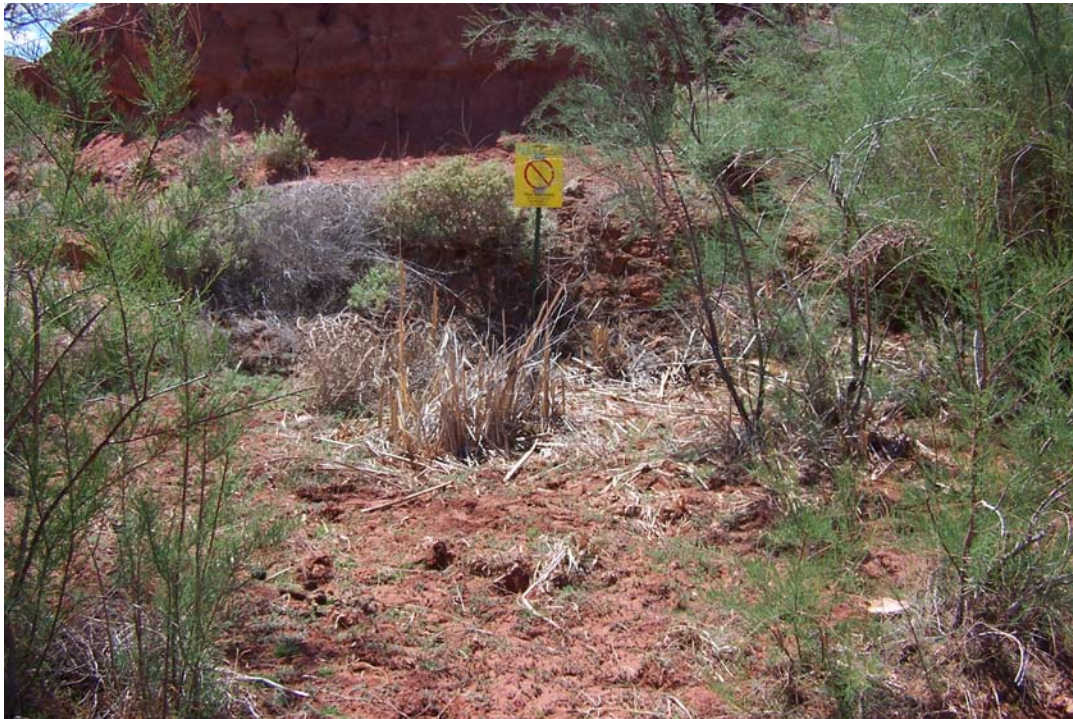
In 2006, seep 0264 was observed to have the most significant flow, although still minimal (note: 2006 observations were made at approximately the same time of the year). Seep 0264 is located directly downgradient of the disposal cell at the confluence of North Arroyo and Gully 2. In 2006, seep 0264 consisted of a wetted area that encompassed approximately 15 feet by 25 feet of riparian vegetation, with standing water (not more than 1 inch in depth) occurring in a couple of locations. In 2007, no standing water was observed at seep 0264 (only a small area of moist soil) and the riparian vegetation was found greatly reduced and stressed from the lack of water (PL-7).

HAT 4/2007. PL-7. Seep 0264.
